## SERVICE BULLETIN #01-51719

### PSS Shaft Seal: Shaft Targeting

Applies To: PSS Type A, PRO, Type B Shaft Seals

May 17, 2019

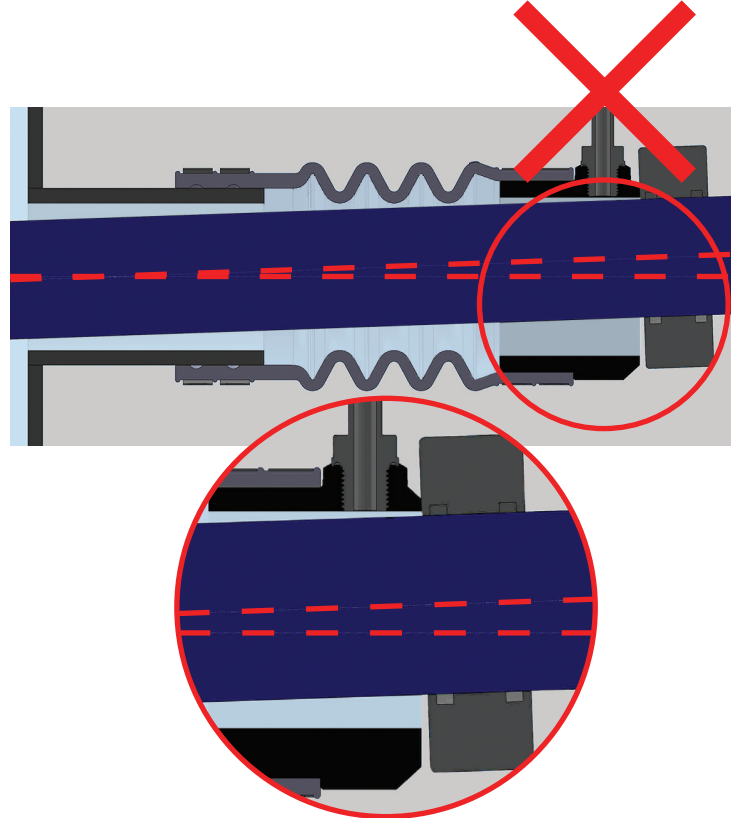
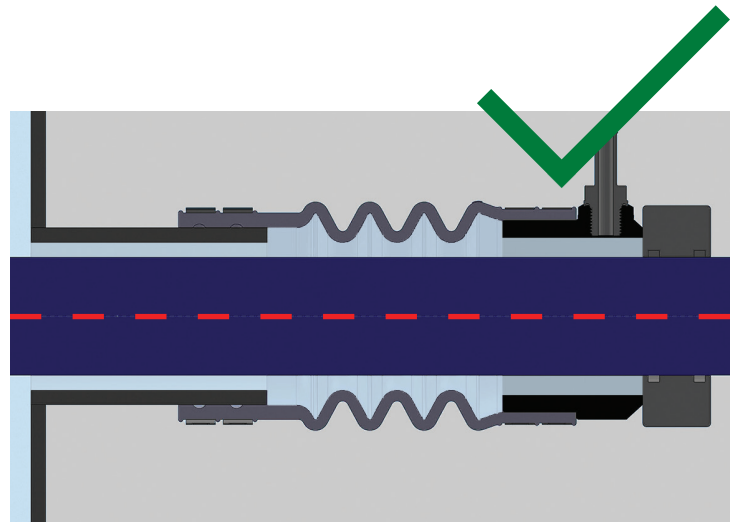
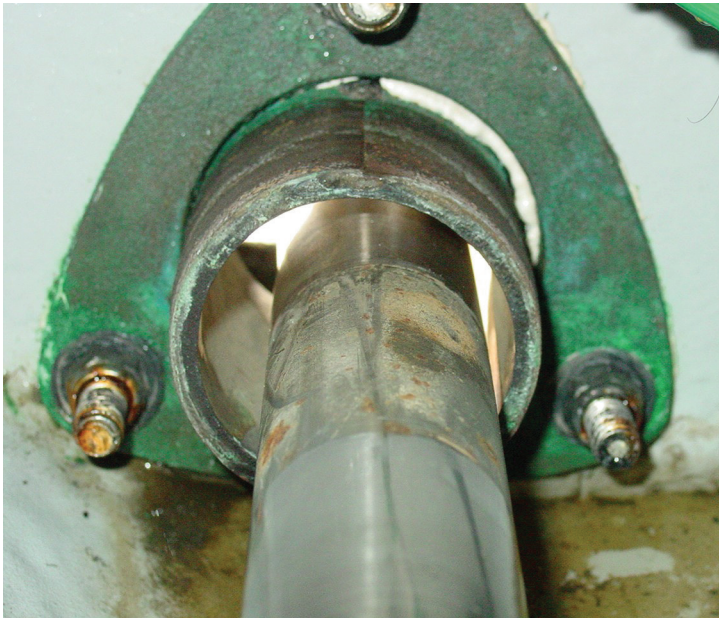
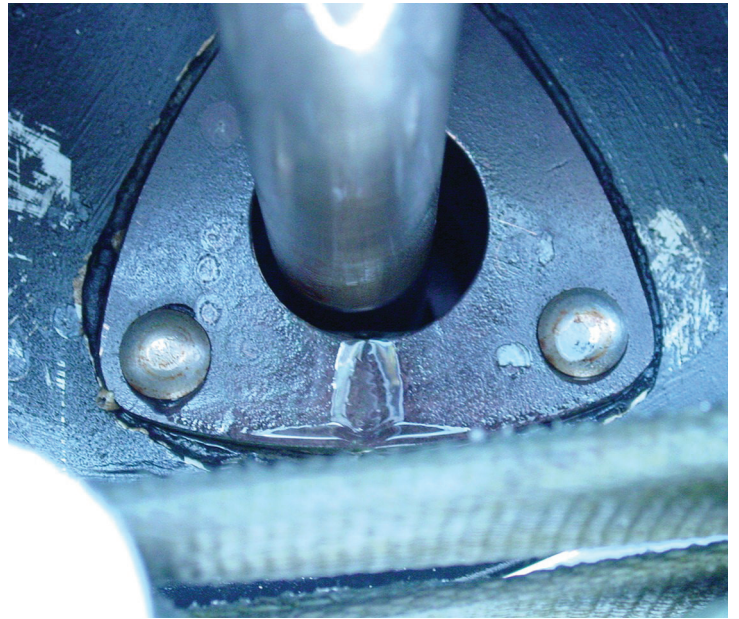
The carbon flange is over-bored to compensate for most misalignment issues, however, there are several boat models that have ‘shaft / stern tube targeting’ issues beyond what the carbon flange ‘standard bore’ can make up for. Shaft targeting (often confused with alignment) is a factor of shaft / stern tube orientation where the shaft is not centered in the stern tube where it enters / exits the boat and or the stern tube not running parallel to the shaft. The result (as depicted to the right) is a shaft that passes through the assembly at an angle and the outcome can be a leaking seal (notably at high rpm) due to the shaft contact inside the carbon flange disrupting the mechanical seal.

Examples of improper shaft centering.

**Step 1:** Adjust the bellow angle on the stern tube in a way that allows the shaft to pass through the center of the carbon component. On a boat with only slight off center shaft or small parallelism issue this fix is usually sufficient.

**Step 2:** Compress the bellow in ¼ inch increments further than the recommended compression (see installation booklet).

**Step 3:** If step 1 or 2 did not fix the problem or if you have a boat know that have a centering/parallelism issue, get from PYI an over-bored carbon component. The extra room in the carbon increases the margin of error and tolerance of the seal for misalignment.
